YARWUN UNIT 2 RELIEF PIT REMEDIATION

Client: Rio Tinto
Location: Yarwun, QLD
Year of Completion: 2023
Project Type: Civil, Industrial Blasting & Painting, Metal Fabrication, Project Services & Shutdown Services

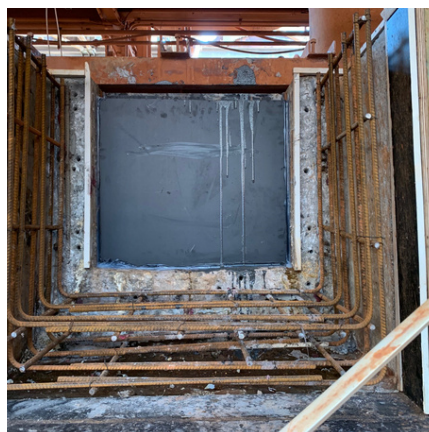
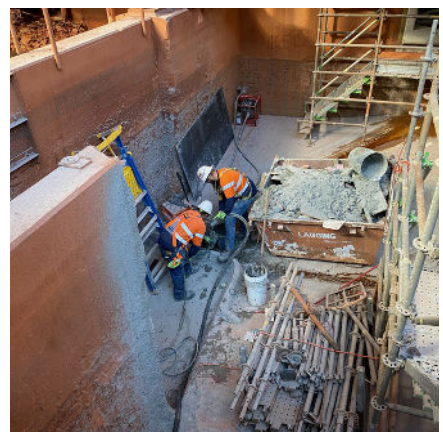
As part of the refining process pits are used to collect caustic sludge which is then disposed of as regulated. Due to the corrosive nature of the material, the concrete walls and floor over time became fatigued exposing the reo bar and causing concrete cancer. Pructon was engaged to undertake the remediation works on the pit. This included the installation of steel plates and high strength Renderoc G grout to improve the longevity of the pit.

- Remediation repair of inlet channels including high pressure water blasting to remove containments and scale build-up; loose concrete removed; 20mm saw cut around perimeter; application of mortar; installation of Fosroc Renderoc G; installation of reinforcing steel.

- Remediation of vertical walls including high pressure water blasting to remove containments and scale build-up; loose concrete removed; Fosroc Nitoprime Zinrich applied to all exposed steel reinforcement; 20mm saw cut around perimeter; threaded anchors installed; installation of Fosroc Renderoc G; installed a steel plates to anchors; application of Fosroc Primer 13 and Fosroc Nitoseal SC600.
